## AVIATION INVESTIGATION REPORT

A03H0002

### COLLISION WITH TERRAIN

CESSNA 208B CARAVAN C-FKAB

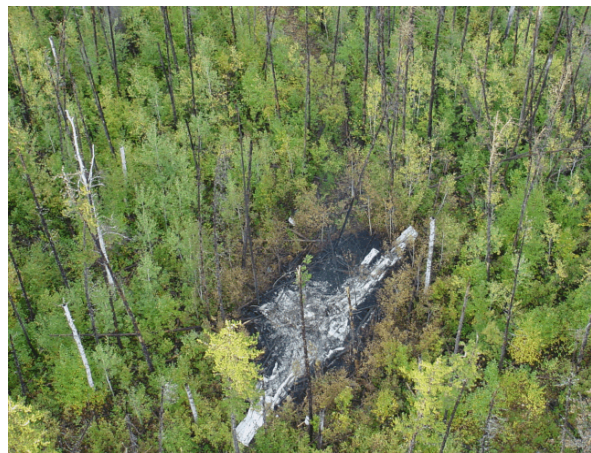
Examination of the wreckage revealed that the aircraft struck heavily wooded terrain in a near vertical attitude with the wings level. The site was located 3.1 nm from Summer Beaver on a 295° M bearing from the threshold of Runway 17. The aircraft knocked down several trees that had occupied the ground where the aircraft came to rest, and there were signs of tree impact to the leading edges of both wings. The aircraft came to rest facing 200° M, with the remains of the wings nearly perpendicular to the fuselage. Fire consumed some trees and most of the aircraft, with the exception of portions of the fuselage, wings, engine, and propeller. The remains of the landing gear, seats, door latches, and cargo pod were identified. No evidence of pre-impact structural failure was identified.

**Photo 1.** Overhead view of accident site

All major components of the aircraft were located at the accident site. No discrepancies were found with the portions of the aircraft that could be examined. Only small fragments of the windshield were found within and immediately outside of the site perimeter.
